RU-C2 Remedial Action

RU-C2 Pre-Design PARCEL C

Hunters Point Shipyard February 2012

Contract No. N62473-06-D-2206 Delivery Order No. 0093

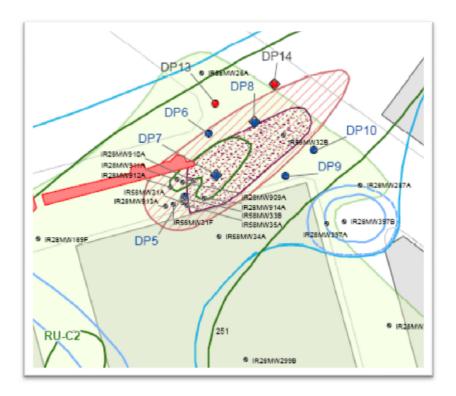
Tier I Groundwater Sample Results Building 251 VOC Remediation Area

PA	L				В	uilding 258	- Resider	ntial PAL		
Analyte	Residential ¹	Industrial ²	LOQ	DP-5-20	DP-6-20	DP-7-20	DP-7-33	DP-8-20	DP-8-37 / FD	DP-9-20	DP-10-20
1,1,2,2-Tetrachloroethane	3	5.1	0.5	0.10	0.10	0.5U	0.10	0.3U	0.10	0.1U	0.1U
1,2,4-trimethylbenzene	25	25	0.5	0.10	0.10	26	0.3J	0.2U	0.10	0.2U	0.1U
1,2-Dichloroethene (total)	210	210	0.5	0.5	0.10	4.9	0.10	2.6	3.8 / 4.1	24.3	1.5
1,2-Dichloropropane	1.1	1.8	0.5	0.10	0.10	0.5U	0.10	0.2U	0.10	0.2U	0.1U
1,3,5-trimethylbenzene	19	19	0.5	0.10	0.10	2.5J	0.10	0.10	0.10	0.10	0.1U
1,4-Dichlorobenzene	2.1	3.6	0.5	0.10	34	130	0.10	15	1/0.9	1.6	0.1U
Benzene	0.5	0.6	0.5	0.10	0.1J	3	0.10	0.10	0.10	0.2J	0.1U
Bromodichloromethane	1	1.7	0.5	0.10	0.10	0.5U	0.10	0.10	0.10	0.1U	0.1U
Carbon Tetrachloride	0.5	0.5	0.5	0.10	0.10	0.5U	1.2	0.10	0.10	0.1U	0.1U
Chlorobenzene	390	390	0.5	0.2J	76	730	1.2	12	0.8 / 0.8	59	0.10
Chloroethane	6.5	NA	1	0.2U	0.20	0.9U	0.2U	0.2U	0.2U	0.2U	0.2U

Chloroform	0.7	1.2	0.5	1.2	0.10	0.6U	0.7	0.10	0.10	0.10	0.10
cis-1,2-Dichloroethene	210	210	0.5	0.5	0.10	4.9	0.10	2.5	3.8 / 4.1	24	1.5
cis-1,3-Dichloropropene	0.5	0.5	0.5	0.10	0.10	0.5U	0.10	0.10	0.10	0.10	0.10
Dibromochloromethane	2.6	NA	0.5	0.10	0.10	0.5U	0.10	0.10	0.10	0.1U	0.1U
Isopropylbenzene	7.8	7.8	0.5	0.10	0.10	3.1	0.10	0.2J	0.10	0.1U	0.1U
Methylene Chloride	27	46	5	0.10	0.10	0.10	0.10	0.10	0.10	0.10	0.1U
Naphthalene	3.6	6	2	0.10	0.10	8.5J	0.10	0.10	0.10	0.1U	0.1U
Tetrachloroethene	0.5	0.9	0.5	0.1J	0.3J	1.0J	0.10	2.2	29 / 29	9	0.1U
trans-1,3-Dichloropropene	0.5	0.5	0.5	0.10	0.10	0.5U	0.10	0.10	0.10	0.10	0.1U
Trichloroethene	2.9	4.8	0.5	1.7	0.3J	0.6U	0.10	1	1/1.1	5.6	0.4J
Trichlorofluoromethane	180	180	1	3.6	0.10	0.6U	0.1J	0.2U	0.5J / 0.5J	0.2U	0.1J
Vinyl Chloride	0.5	0.5	0.5	0.2U	0.2U	0.8U	0.20	0.10	0.2U	2.4	0.2U

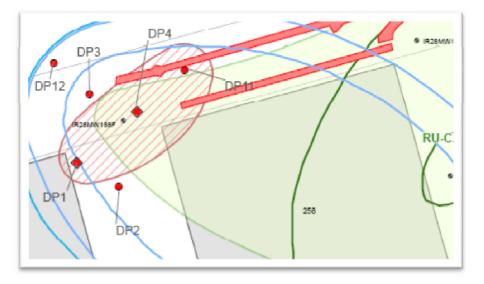
Occurrence of Bedrock

DP1 through DP4 encountered competent bedrock (serpentine) at 3 feet bgs
